# Industrial Water Division

## Case Study

### 3M Corporate Headquarters 2014

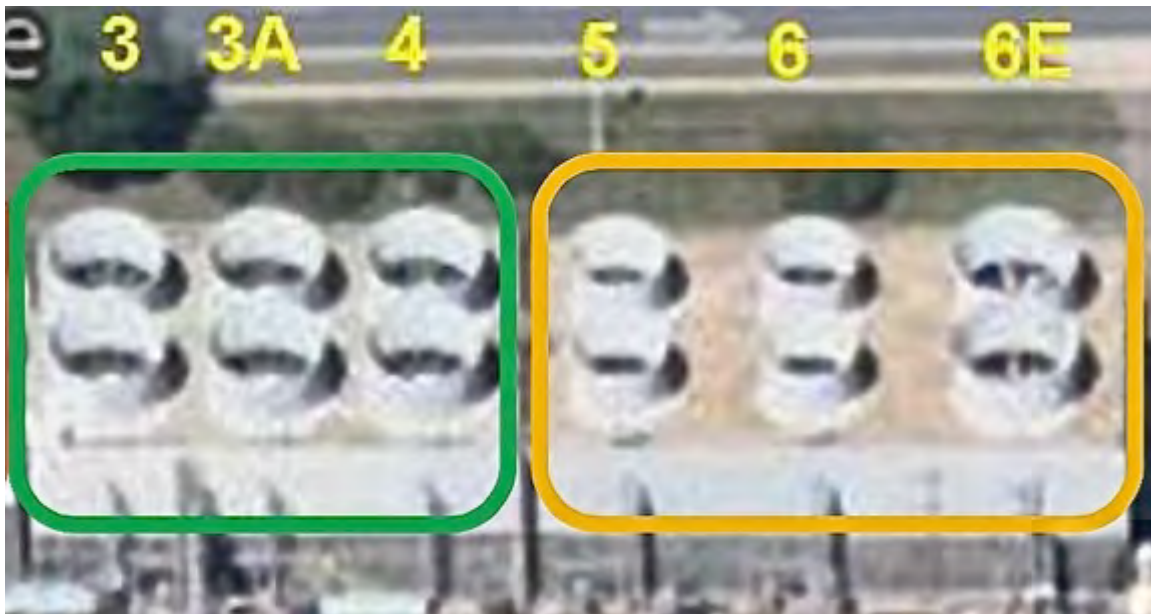
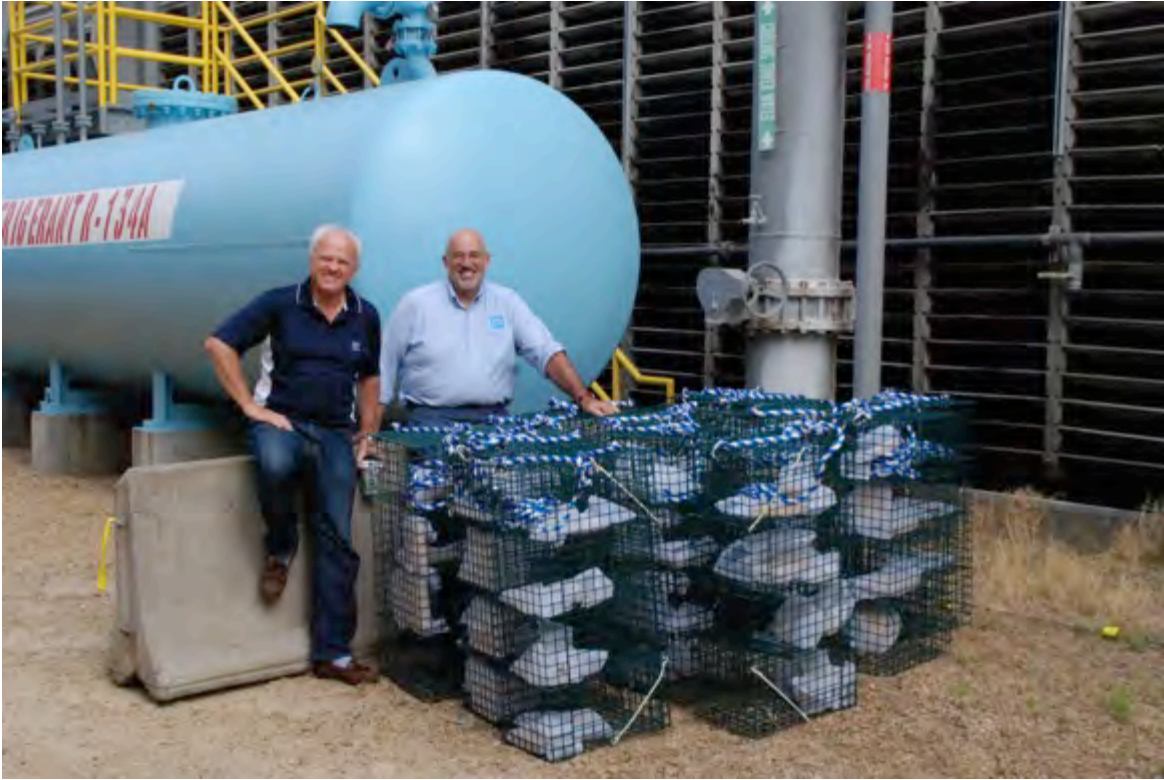
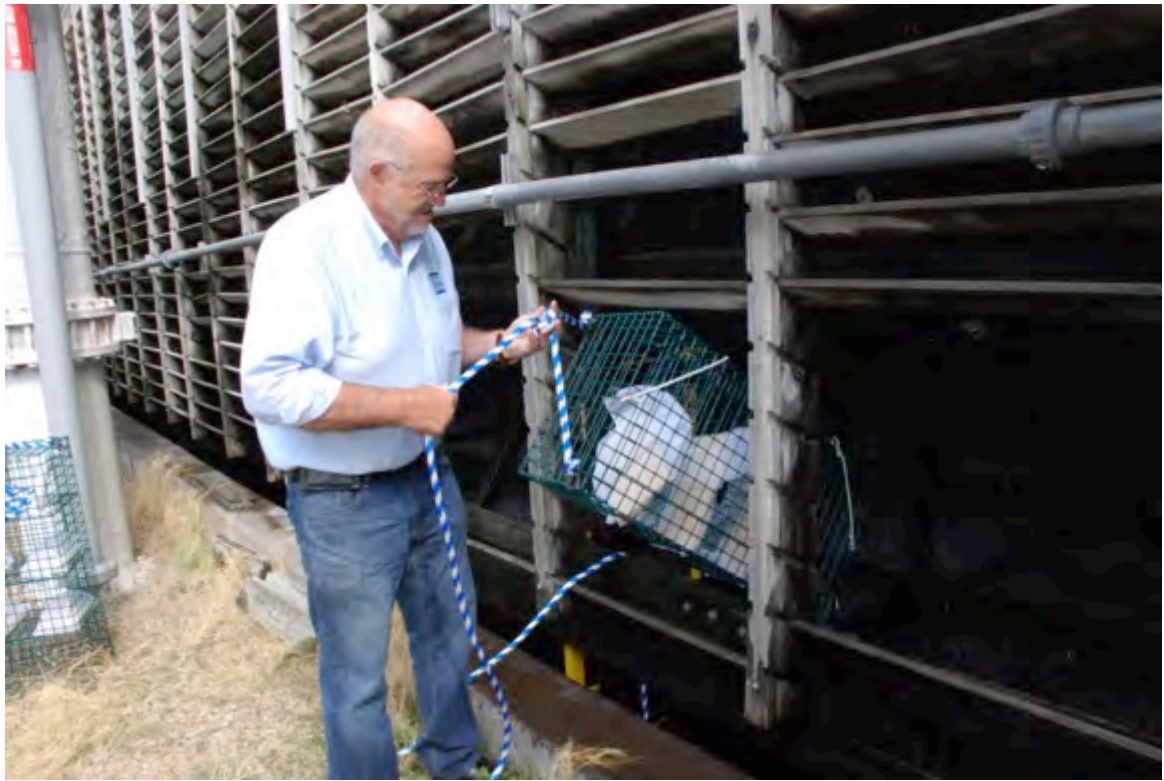
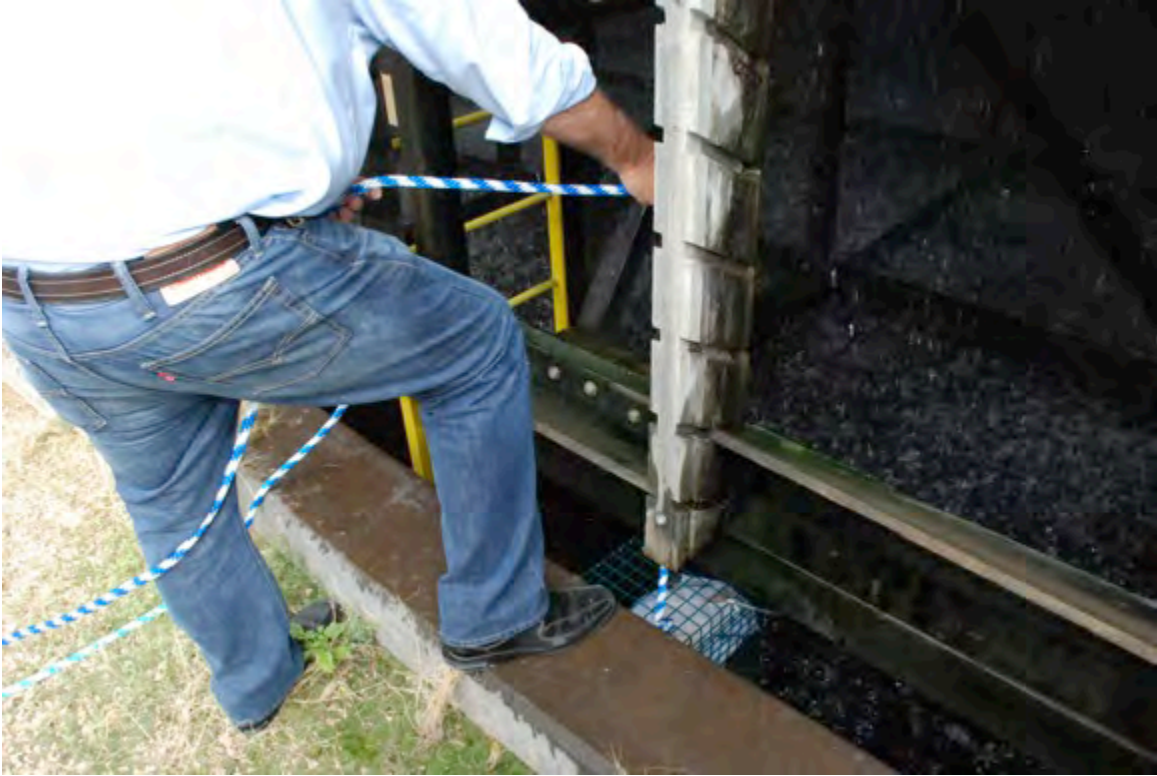
The 2 towers selected for the trial were 7000 ton structures made from wood and galvanized steel. The ProMoss™ treated tower was 3, 3A and 4 – the control tower was 5, 6 and 6E. Due to the cool summer, the control tower was not running approximately 80% of the trial, while the ProMoss™ tower was running all summer.

The ProMoss™ tower required 93 ProMoss™3 bags per month delivered in 13 submersible contact chambers.

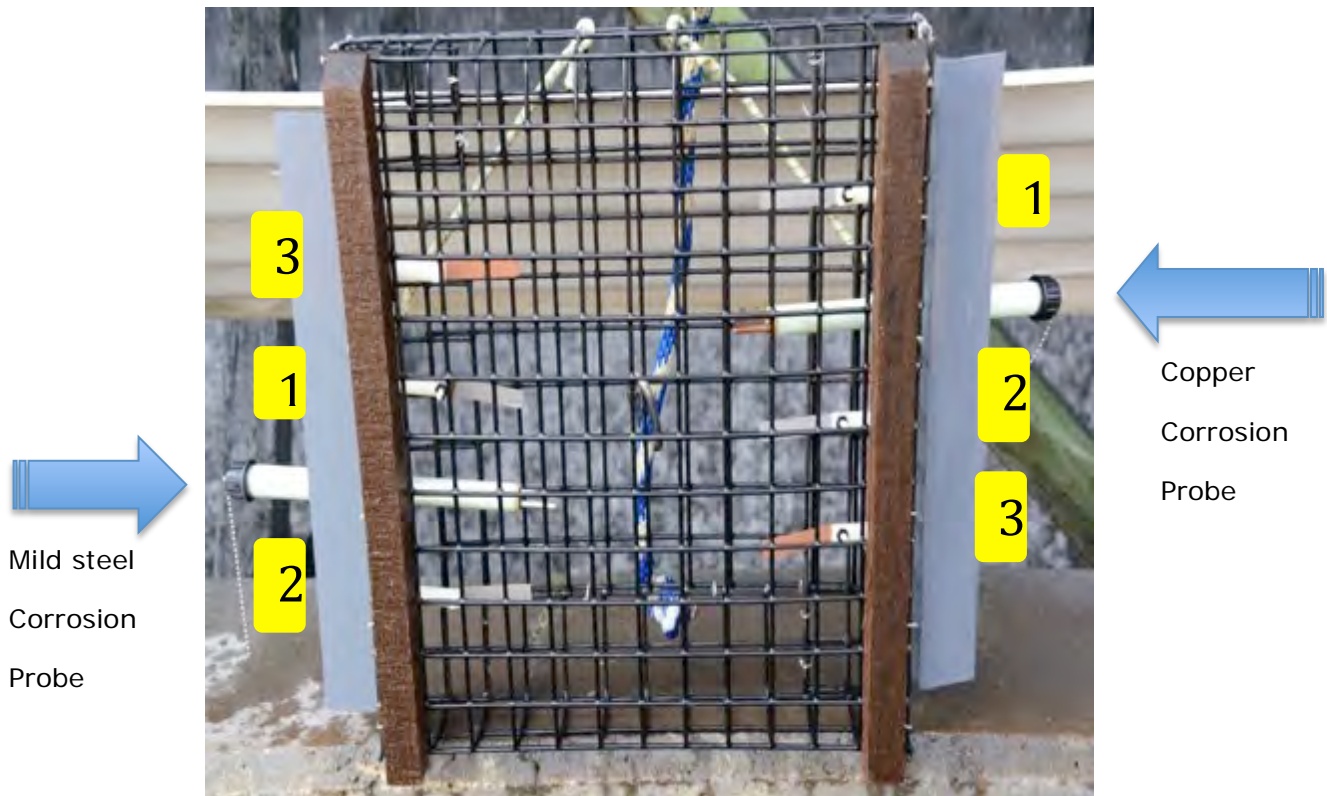
## Test cage for each tower

1. Organic contamination coupon
2. Mild steel corrosion coupon
3. Copper corrosion coupon

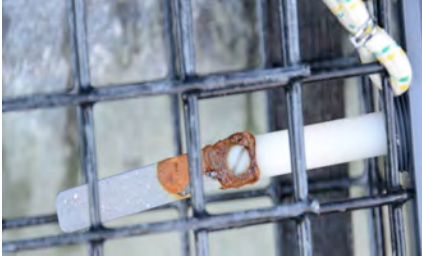
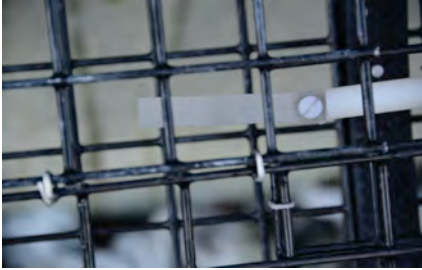
**Tower 3  
Treated with ProMoss™**

**Aug 1, 2014**

The difference between the two towers is visibly evident for the mild steel coupons on the top and the organic contamination coupons on the bottom.

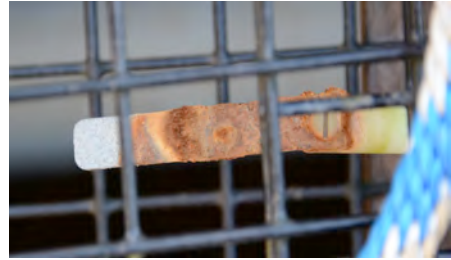
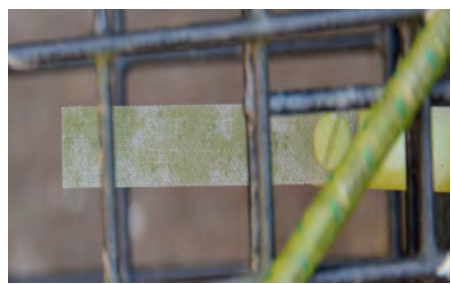
**Tower 5  
Control Tower**

**Aug 1, 2014**

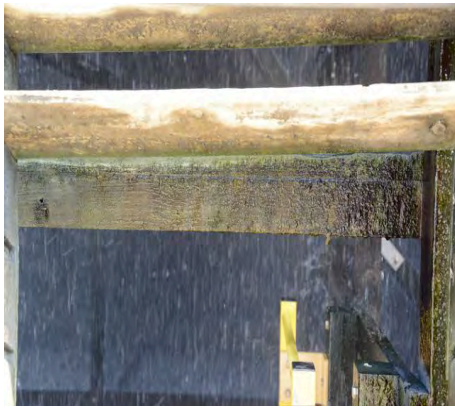
**Tower 3 - Aug 8, 2015**

Midway through the summer the thick layers of organic contamination and algae started to peel off the cedar wood structure of the tower with ProMoss™. The wood was totally intact.

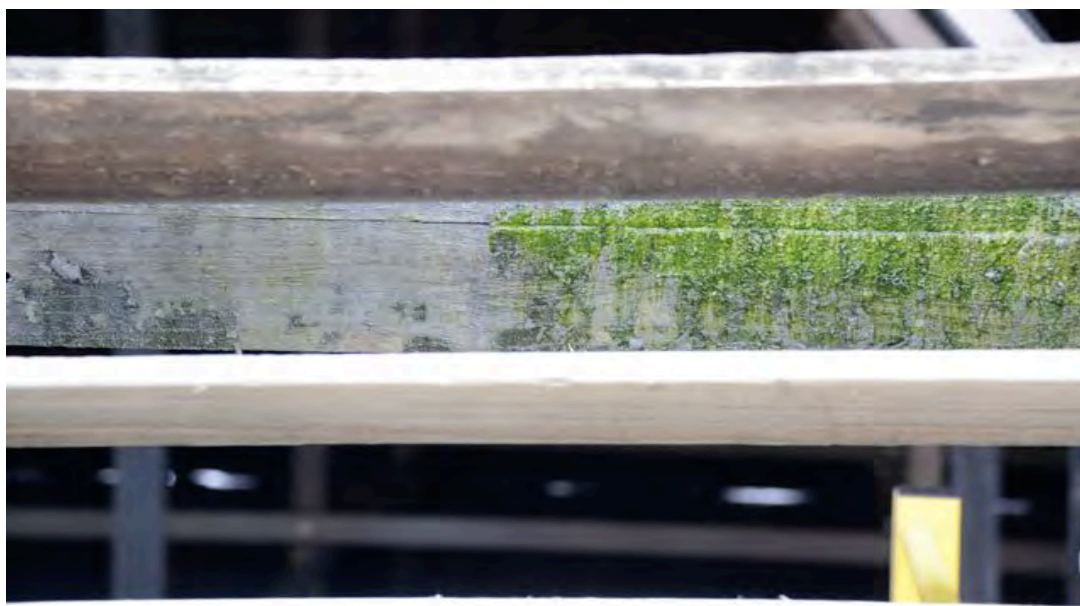
Tower 3 - Oct 17, 2014

By the end of the trial, almost all the organic contamination and algae had peeled off the tower structure. You can see the normal appearing wood on the left of the picture.

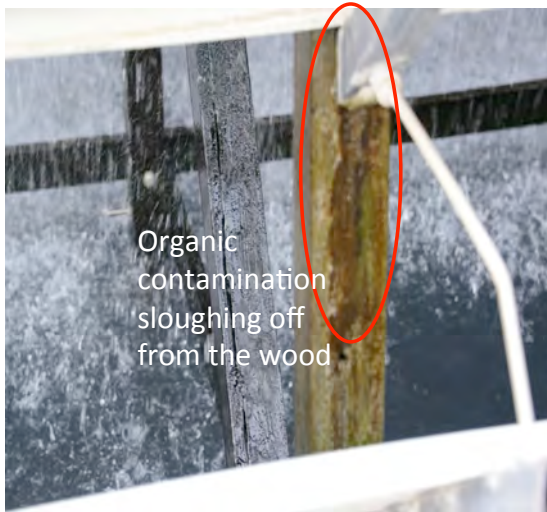
ProMoss™  
Treated

The photo on the left shows organic contamination and algae coming off an upright in the ProMoss™ treated tower while the control tower continued to accumulate more material. After the trial both towers were drained and power-washed. All the timbers in the treated tower were clear of contamination, while the control tower continued to have significant contamination.

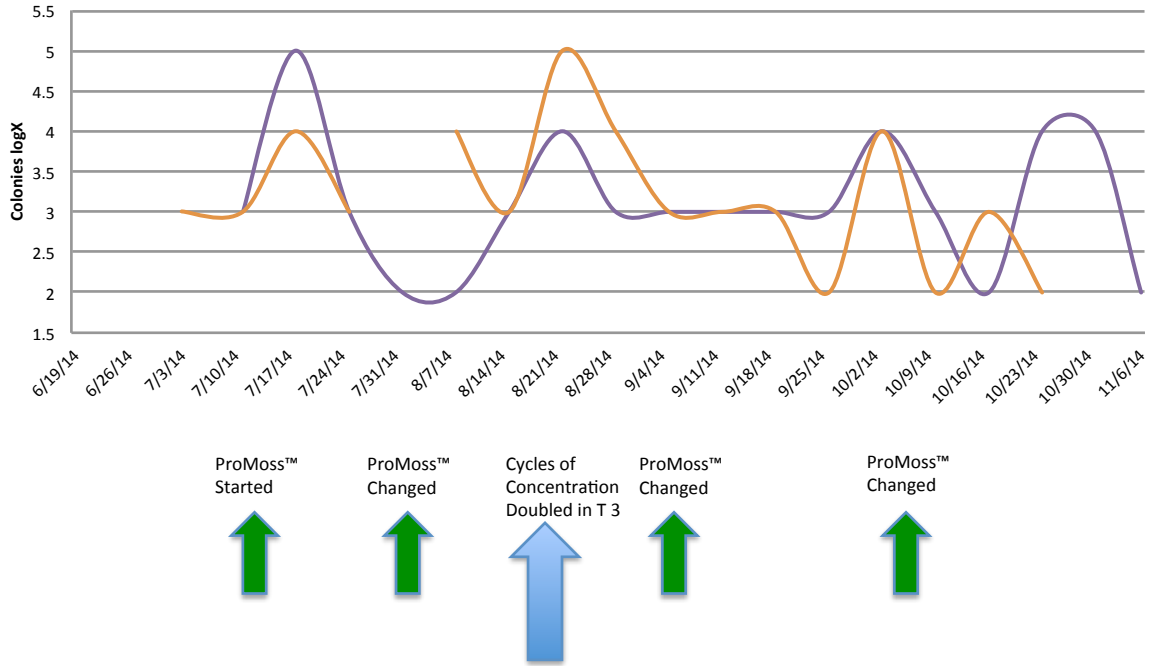
**Quantitative Bacterial Colony Counts**  
**ProMoss™ Tower yellow**  
**Control Tower Violet**

The ProMoss™ treated tower did not have biocide and the control tower did receive biocide. The quantitative bacterial counts from both towers were similar even after the ProMoss™ tower had the cycles of concentration doubled and the control tower remained at the previous years settings.

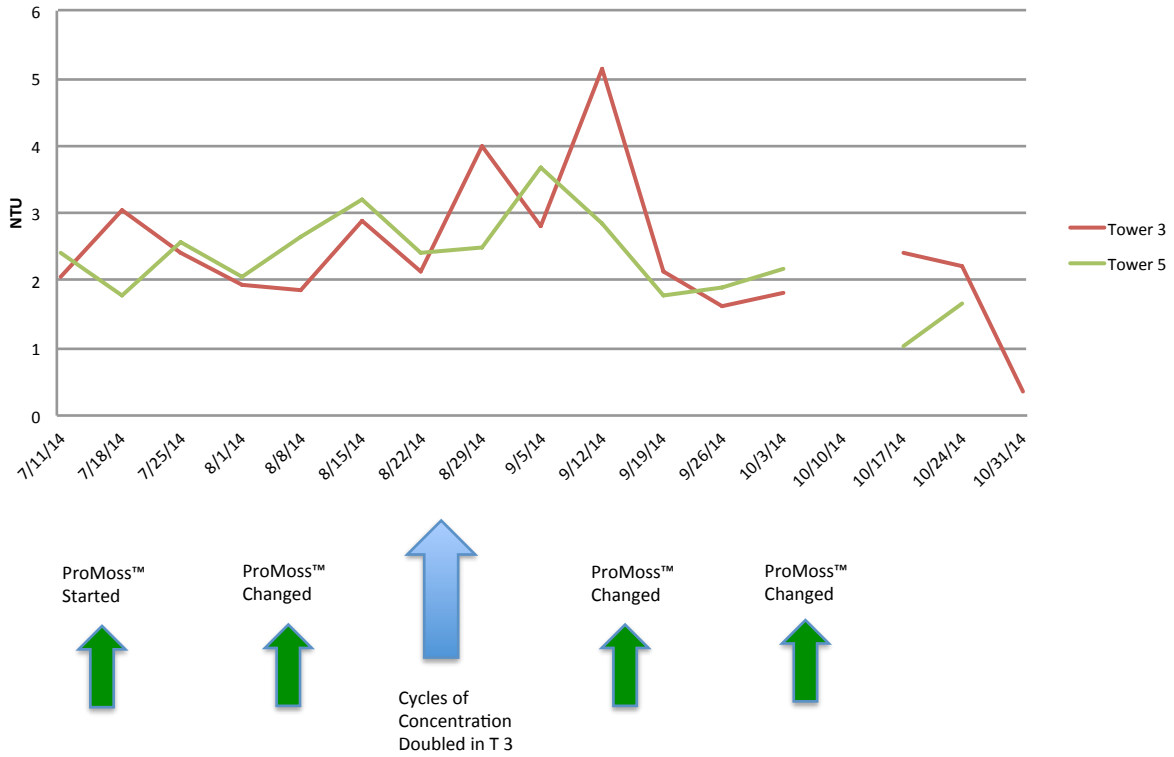
### Cooling Tower Turbidity ProMoss™ Tower Red Control Tower Green

Turbidity was similar in the two towers until the cycles of concentration were increased in the ProMoss™ tower. It then increased for four weeks and then returned to levels similar to the control tower.

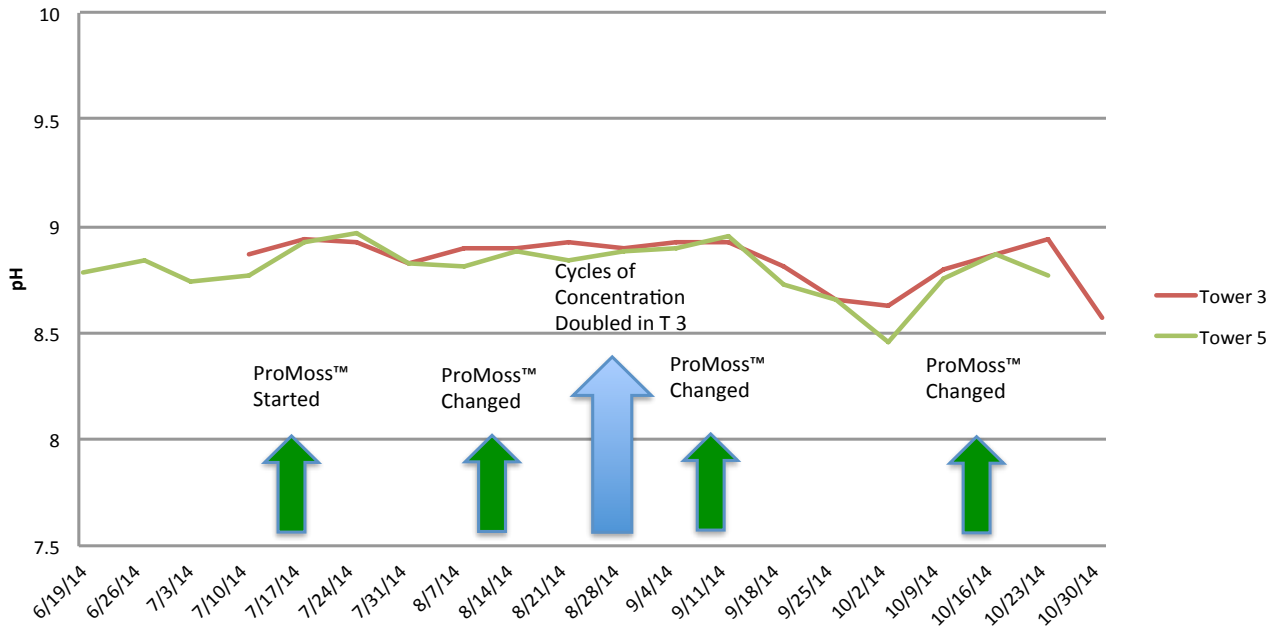
## Cooling Tower pH ProMoss™ Tower Red Control Tower Green

pH measurements were similar in both towers even with the increase in cycles of concentration in the ProMoss™ treated tower.

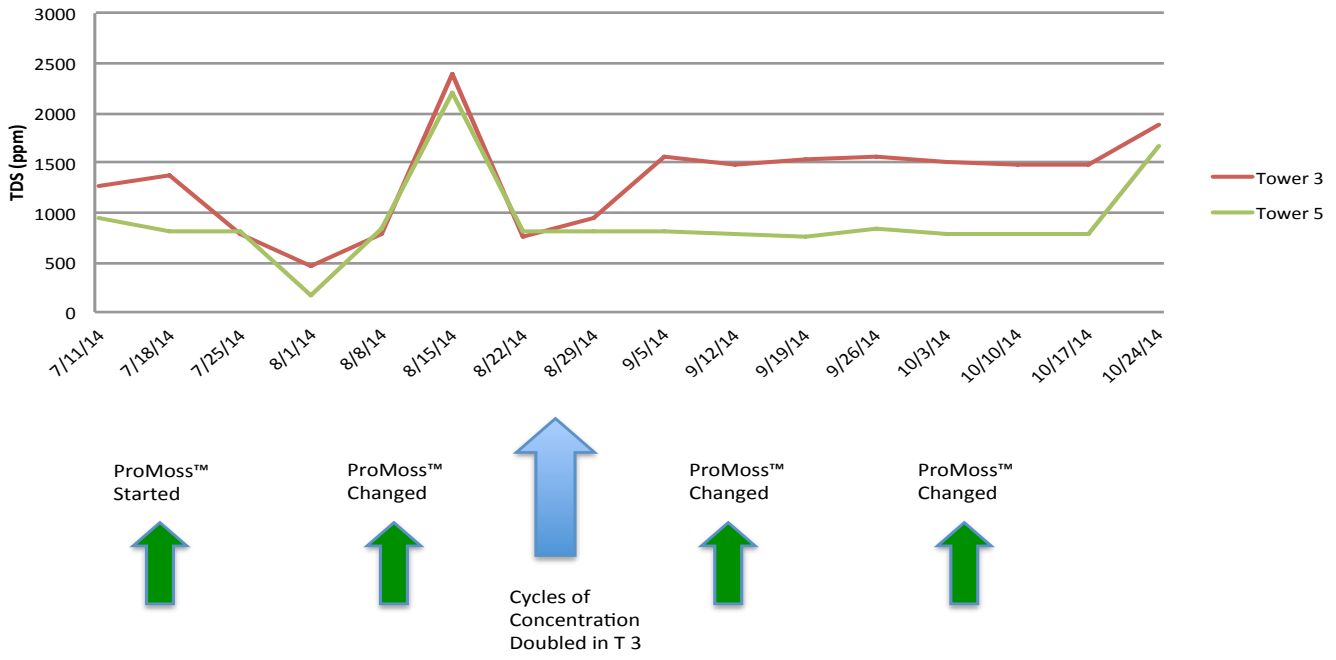
## Cooling Towers – TDS ProMoss™ Red Control Green

Total dissolved solids (TDS) were similar until the cycles of concentration were doubled in the ProMoss™ treated tower. It then increased in the ProMoss™ treated tower.

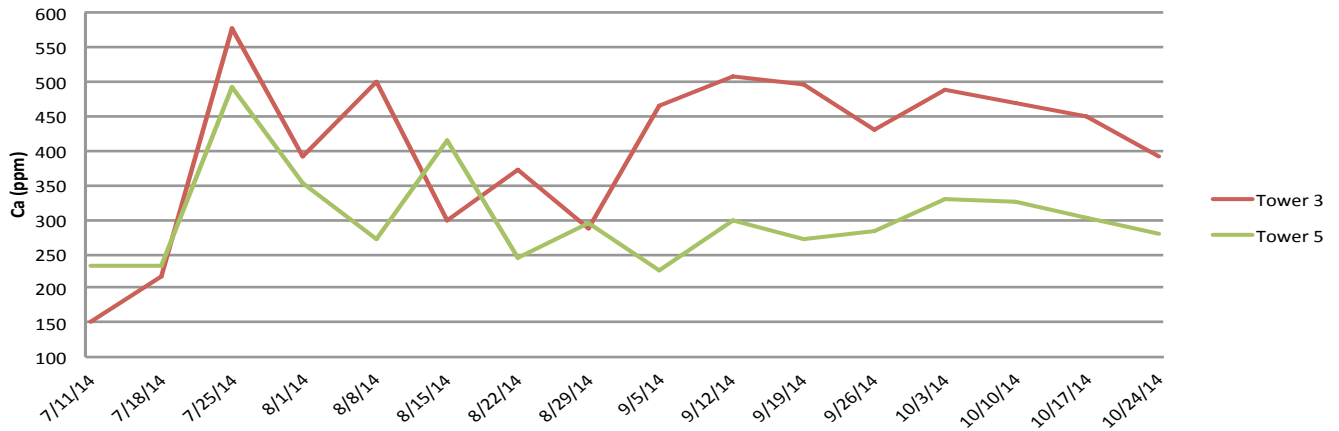
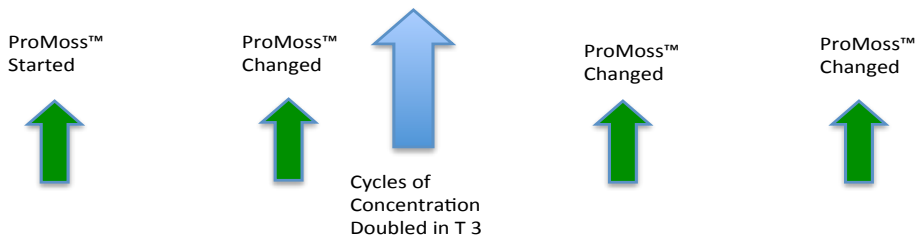
## Cooling Towers – Calcium ProMoss™ Red Control Green

Calcium hardness measurements were similar in both towers until the cycles of concentration were increased. This resulted in an increase in the ProMoss™ treated tower compared to the control tower.

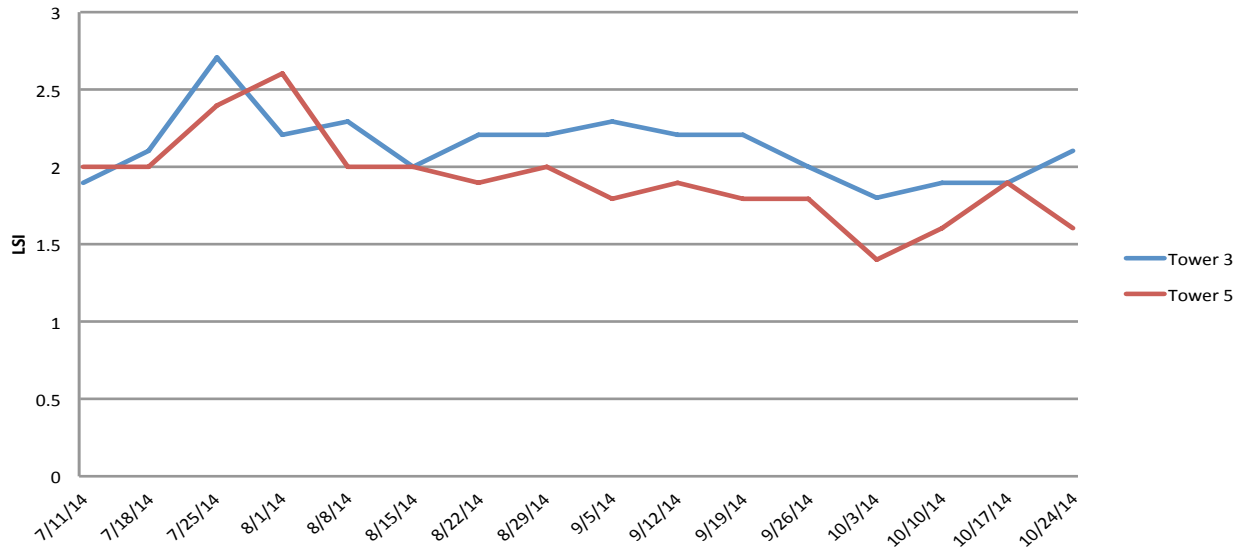
### LSI Calculation ProMoss™ Blue Control Red

The Langlier Saturation Index (LSI) was calculated for both towers. Nalco was concerned with the +2 level in the ProMoss™ treated tower and predicted that the chiller would be significantly scaled. After the cooling season was over, the chiller was opened for cleaning and the only scaling was on the zinc anodes.

After the cooling season in 2014 was completed the chiller for the ProMoss™ tower was opened for cleaning. There was no corrosion in the tower and the only scale formation was on the zinc anodes. That scale was analyzed and found to be zinc and oxygen. The +2 LSI predicted that the chiller would be scaled, but no calcium scale was found. The calcium was being absorbed into the Sphagnum moss leaves and removed from the circulating water. Using a scope to inspect the chiller tubes, there was no visible corrosion or scale formation.

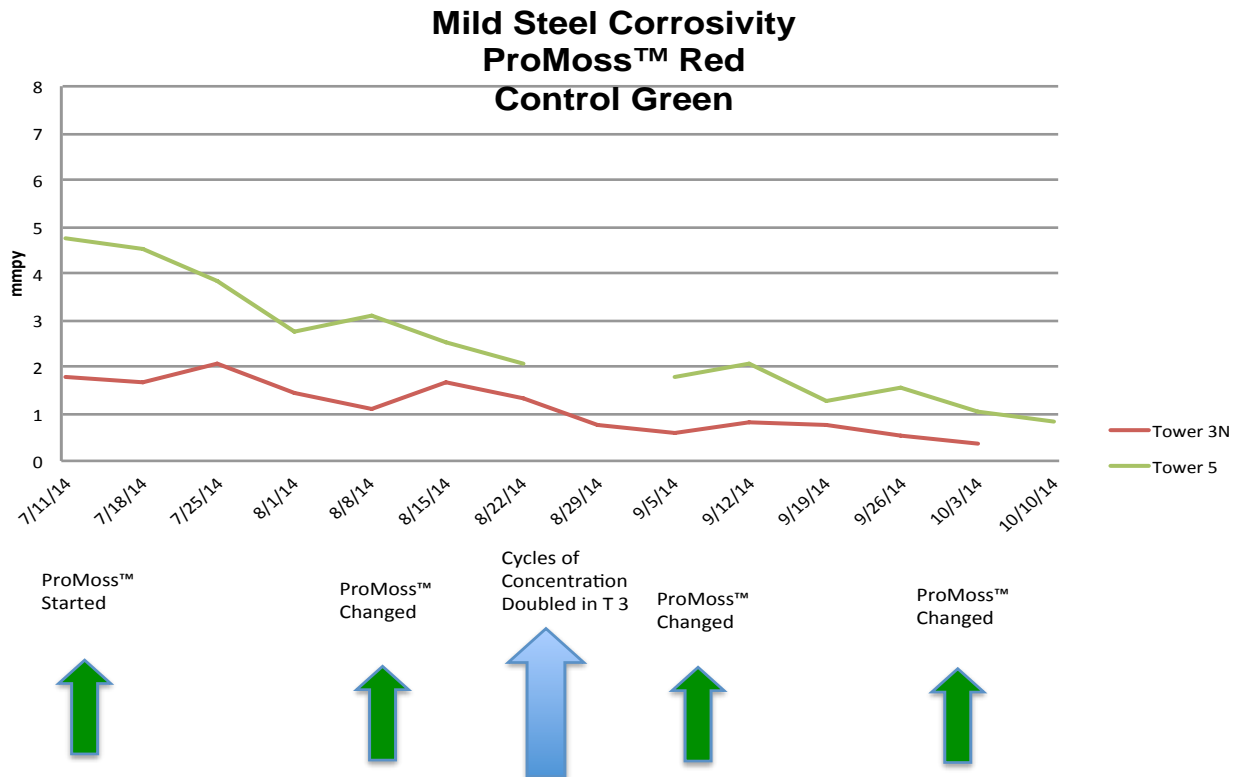
Corrosivity for mild steel measured with the linear polarization probe was significantly lower in the ProMoss™ treated tower compared with the control tower even after the cycles of concentration was doubled.

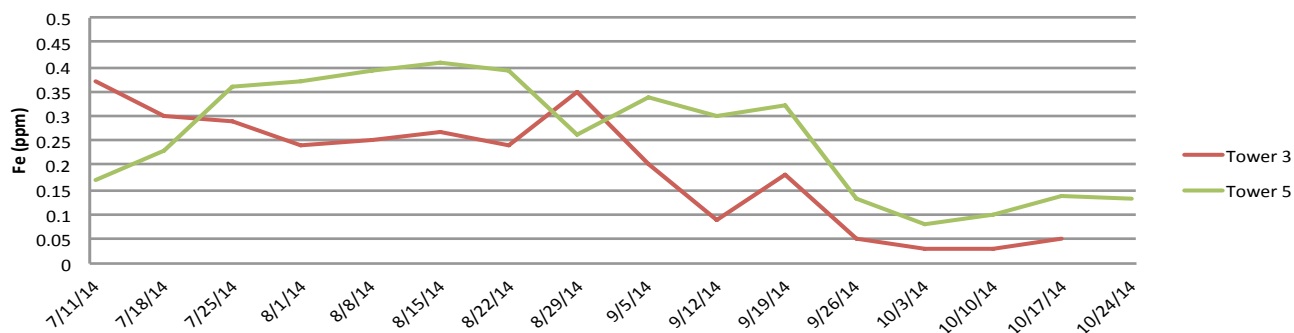
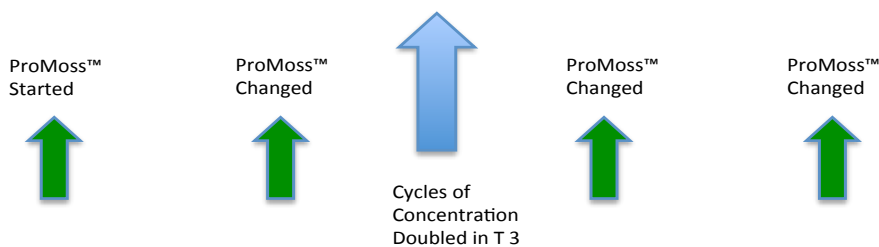
## Cooling Towers – Fe ProMoss™ Red Control Green

Iron levels in the water were significantly lower in the ProMoss™ treated tower and continued to decrease throughout the cooling season reflecting the ability of Sphagnum moss to absorb iron ions.

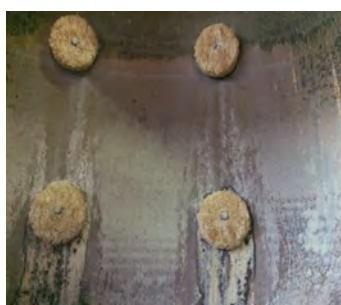
Zinc Anodes

Mass percent [%]		
Element	Front Anode 4A chiller	Back Anode 4A chiller
Oxygen (O)	36.0	35.3
Iron (Fe)	0.047	0.079
Carbon (C)	6.55	5.91
Silicon (Si)	3.20	5.34
Phosphorous (P)	0.946	1.09
Calcium (Ca)	0.046	0.287
Zinc (Zn)	49.8	49.1
