# Industrial Water

Cooling Tower

Case studies and analysis

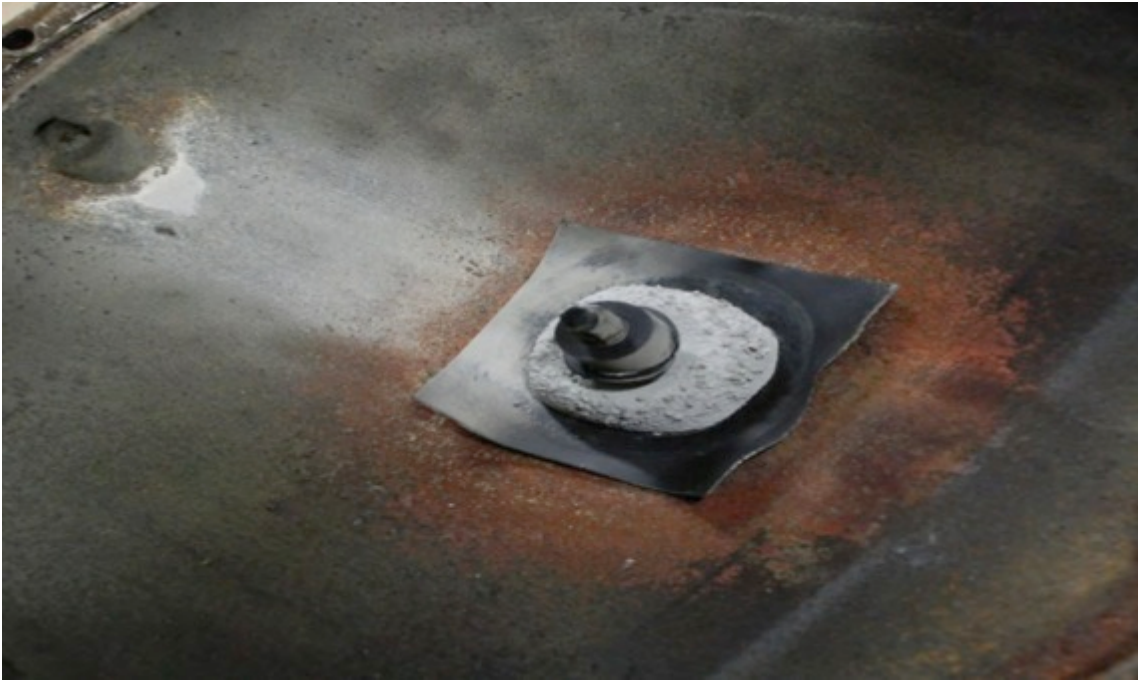
*Chiller lid from phase one test facility after two cooling seasons on ProMoss™.*

All treatments stayed the same except the blow-down setting was increased from 1800 to 3600 to see if the increased TDS would result in scale formation, corrosion or less efficient chemical control. No scaling occurred on the tower, there was a decrease in chemical consumption, and it took 0.5 hours to clean the tower the next year. The heat exchanger was scheduled for maintenance during the winter. There was no scaling or corrosion on the exchanger tubes and no cleaning was required.

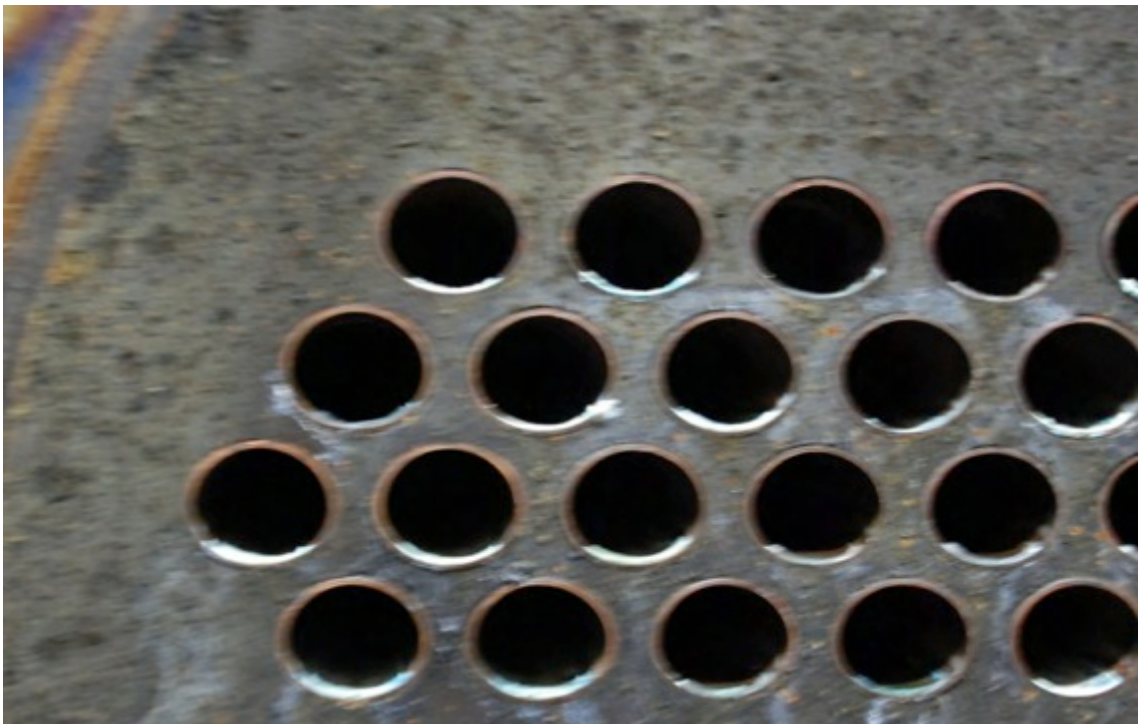
*Chiller tubes from phase one test facility after two cooling seasons on ProMoss™*

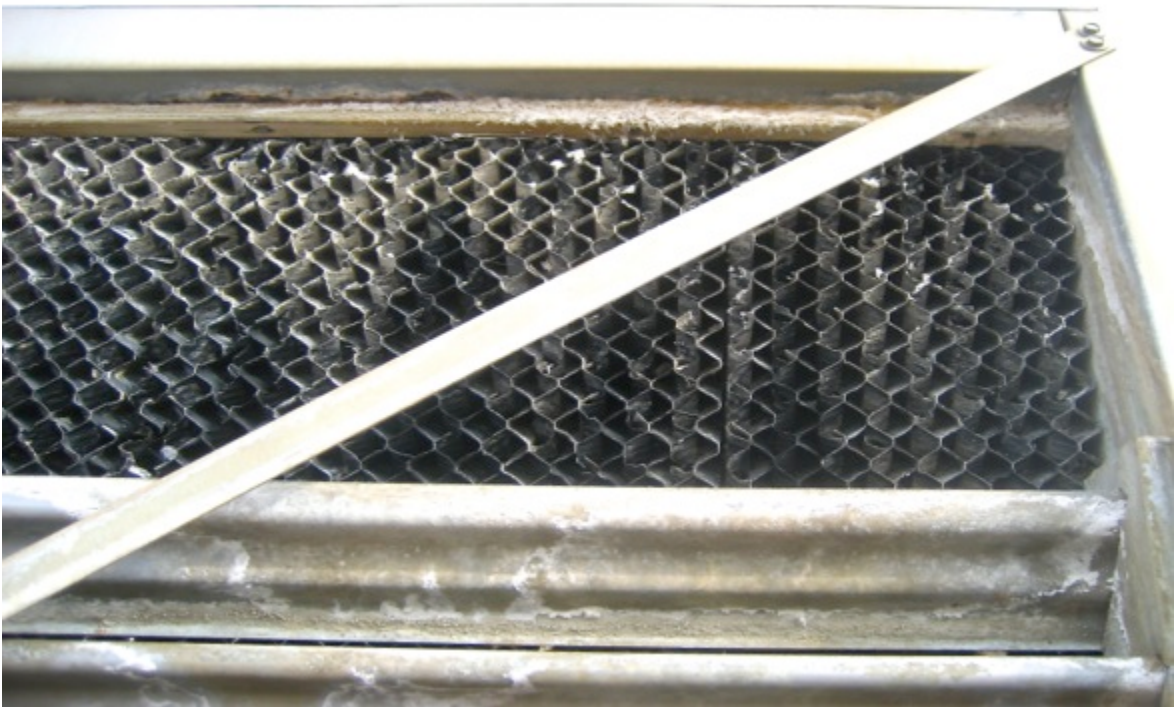
*Cooling tower media from 16 year old phase one test facility before starting on ProMoss™*

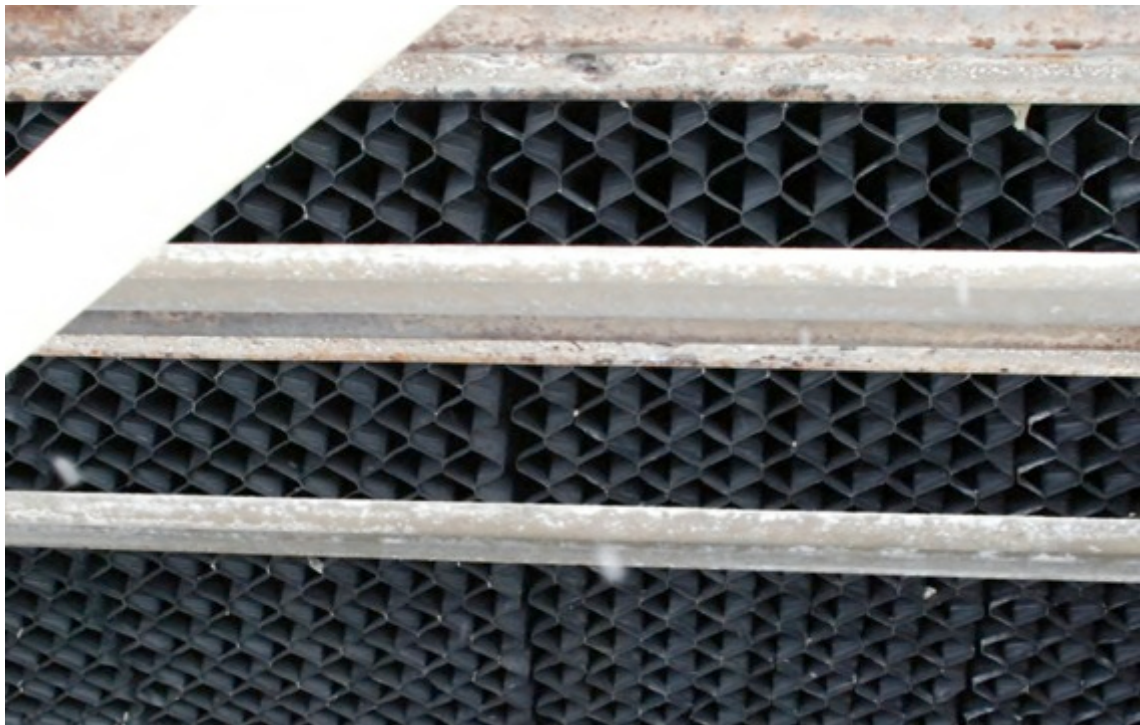
*Cooling tower media from 16 year old phase one test facility after two cooling seasons on ProMoss™*

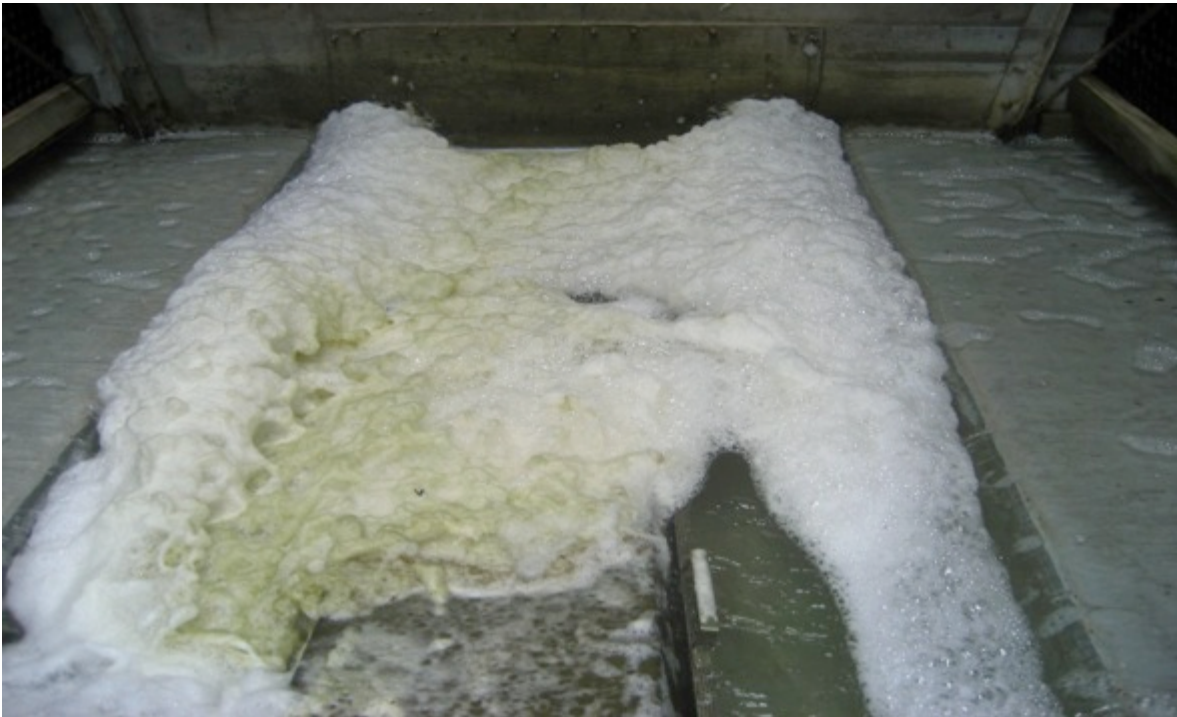
*Water, foam, and organic contamination before starting on ProMoss™*

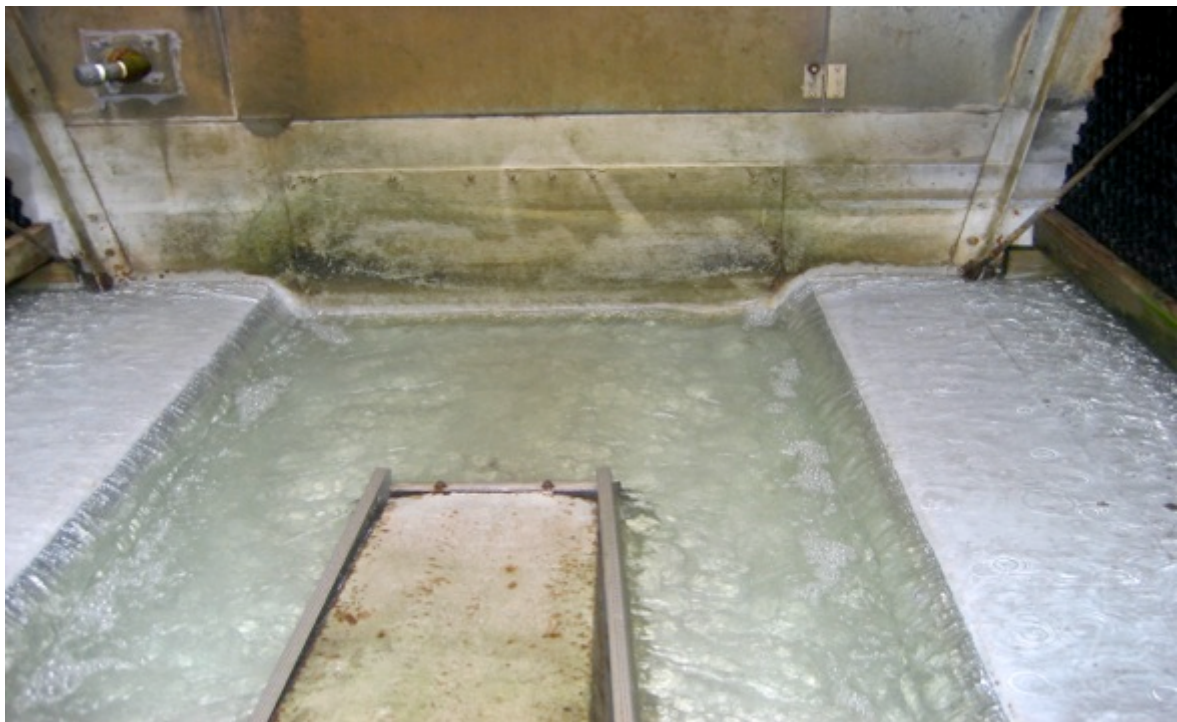
*Water after two years treatment with ProMoss™ Note clarity, absence of foam and organic contamination*

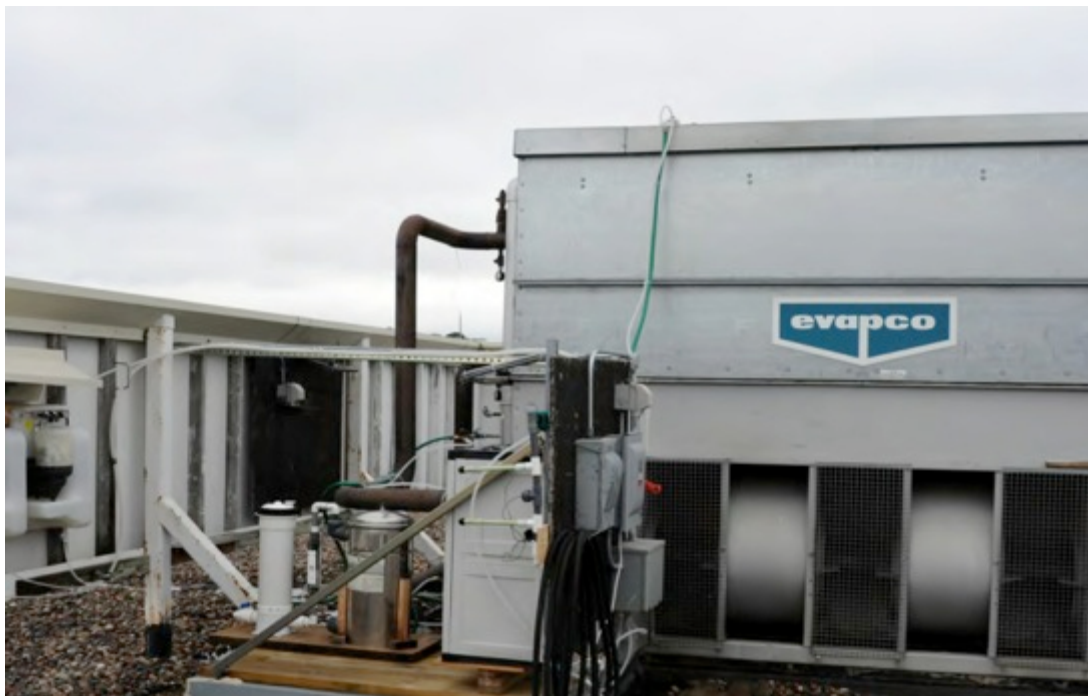
Sphagnum moss delivery system used on three different facilities. Stainless steel tank contains the Sphagnum moss, white PVC cylinder is a filter and two LPR probes are in line.

We contracted a local water treatment company, Jay Tech, to independently test three different facilities. They created a flow through system with a filter and separate contact chamber similar to the system used to deliver the Sphagnum moss to a residential pool (Figure 2). LPR probes for galvanized and soft steel were installed inline. Sphagnum moss treatment was started on July 14, biocide delivery remained unchanged, and corrosion, dispersant and scale inhibitors were stopped.

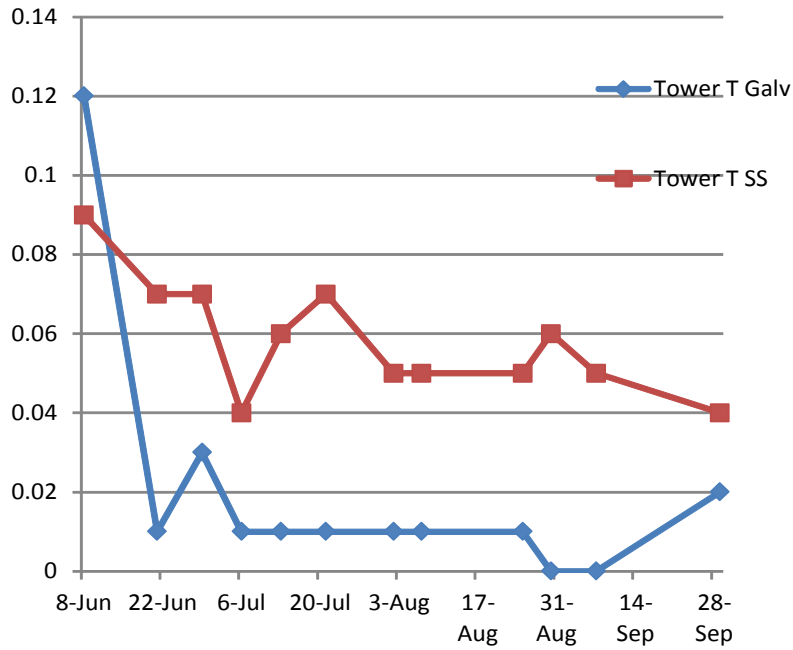
Corrosion values for Phase Two tower 1. Galvanized steel is in blue and soft steel in red. Dispersant and corrosion inhibitors removed on July 14.

We concluded that the measured corrosion was the same as or decreased when the corrosion inhibitor was discontinued on all three towers. The flows through systems had frequent fouling of the filters, were expensive, and were removed. We decided to return to the contact delivery cages in the basin of the towers for the next studies.

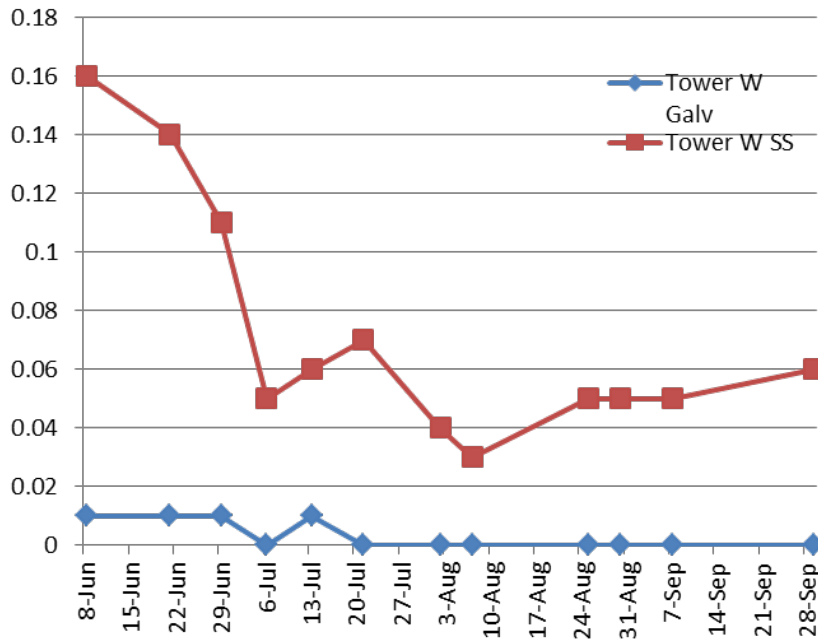
Corrosion values for Phase Two tower 2. Galvanized steel is in blue and soft steel in red. Dispersant and corrosion inhibitors removed on July 14.

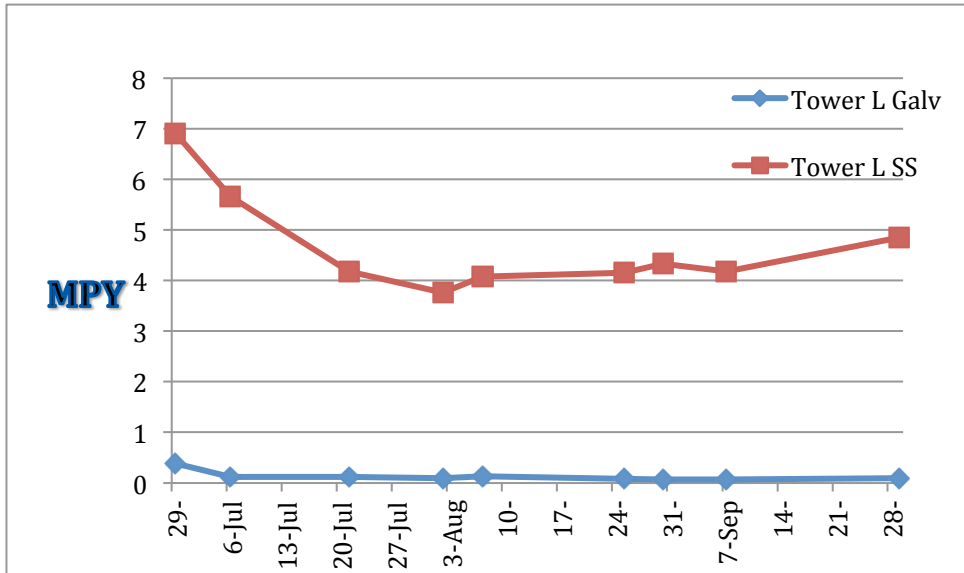
*Corrosion values for Phase Two tower 3*

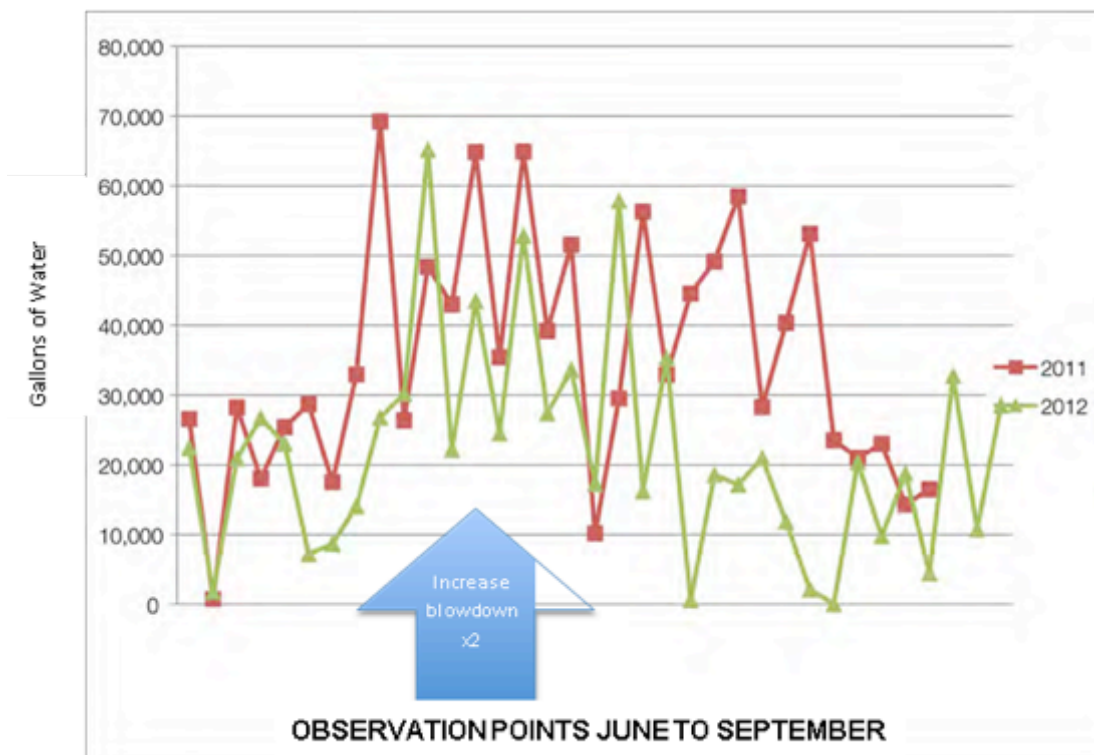
*Water use comparison from Phase Three. Red is water used in 2011 with no Sphagnum moss and green is water used in 2012 with Sphagnum moss. Blue arrow is when blow-down setting is increased from 1800 to 3600 in tower 3. Temperature means for both years are similar*

Corrosion for galvanized remained below 0.6 mpy on tower #4 after the corrosion inhibitor was removed, and below 0.7 mpy on tower #3 after the blow-down was doubled on tower #3. Water use decreased by 42% on tower #3 after the blow-down was doubled. All dip slides for bacteria were negative, and scaling was observed to decrease on both towers.

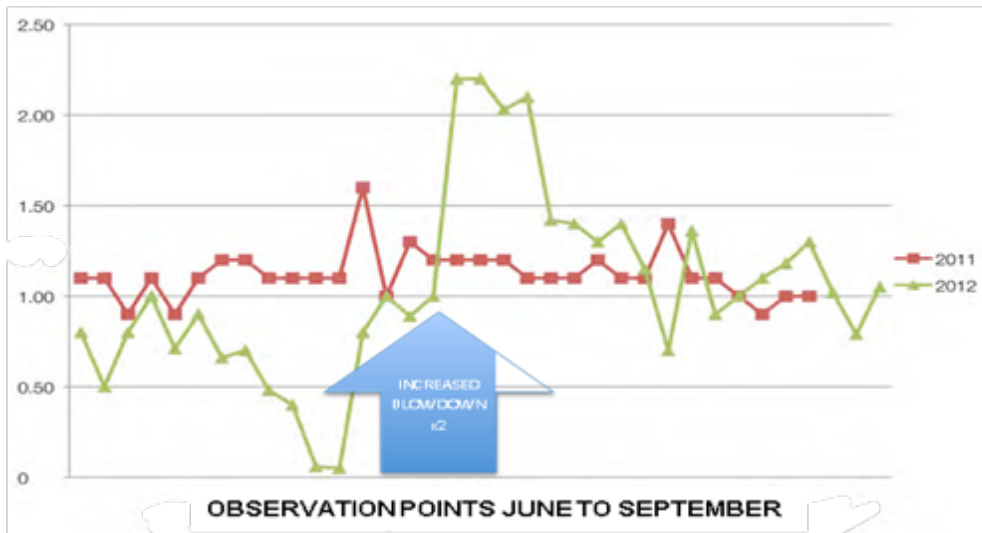
Corrosion inhibitor concentration comparison from Phase Three. Blue arrow is when blow-down settings were increased from 1800 to 3600

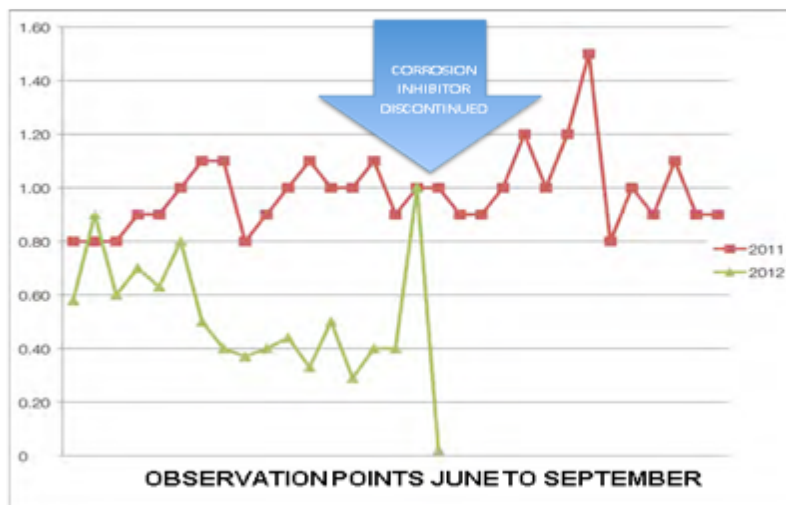
Corrosion inhibitor concentration from Phase Three tower 4. The blue arrow indicates when corrosion inhibitor feed was discontinued. Corrosion for galvanized steel was 0.09 mpy with corrosion inhibitor and Sphagnum moss and 0.55 mpy when corrosion inhibitor was discontinued.

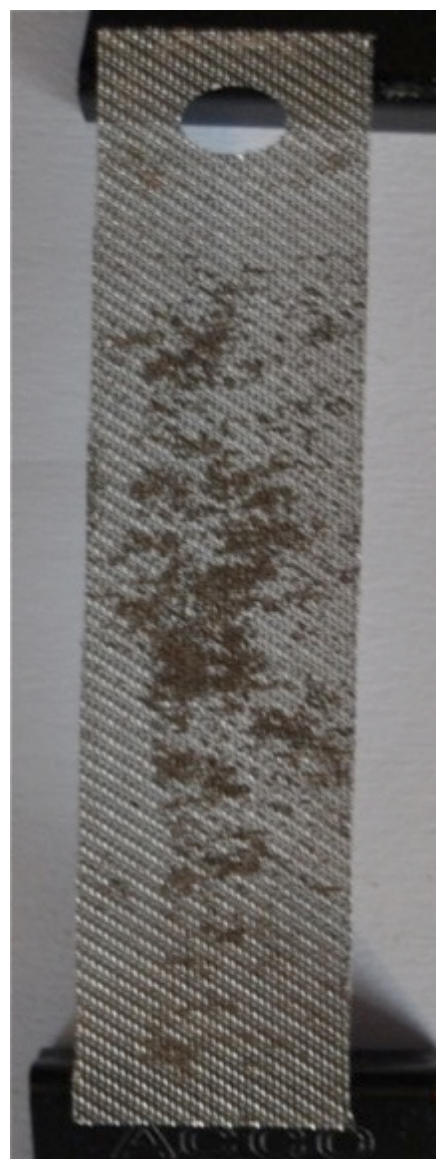
## ORGANIC CONTAMINATION ACCUMULATION

Control Cooling Tower without ProMoss™

Water was treated with two biocides, a dispersant  
and corrosion inhibitor.

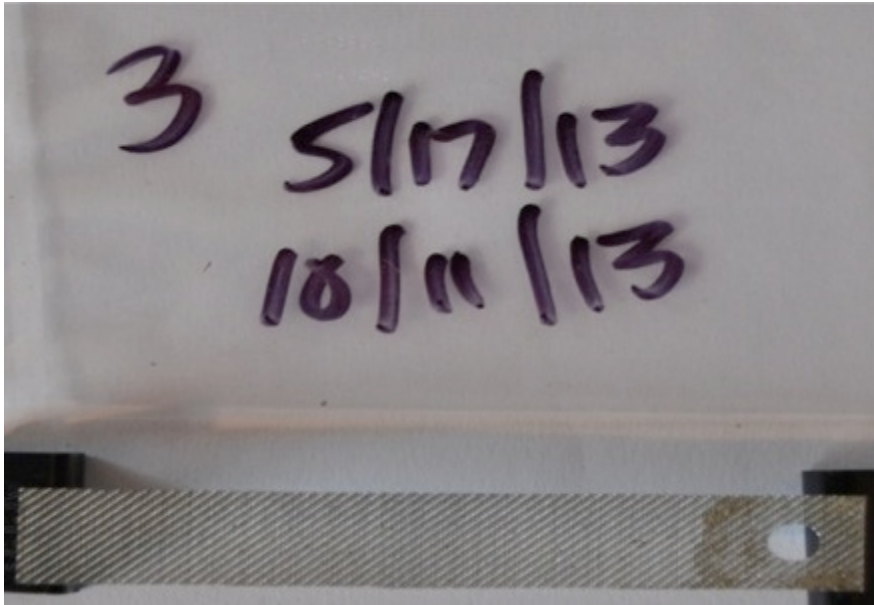
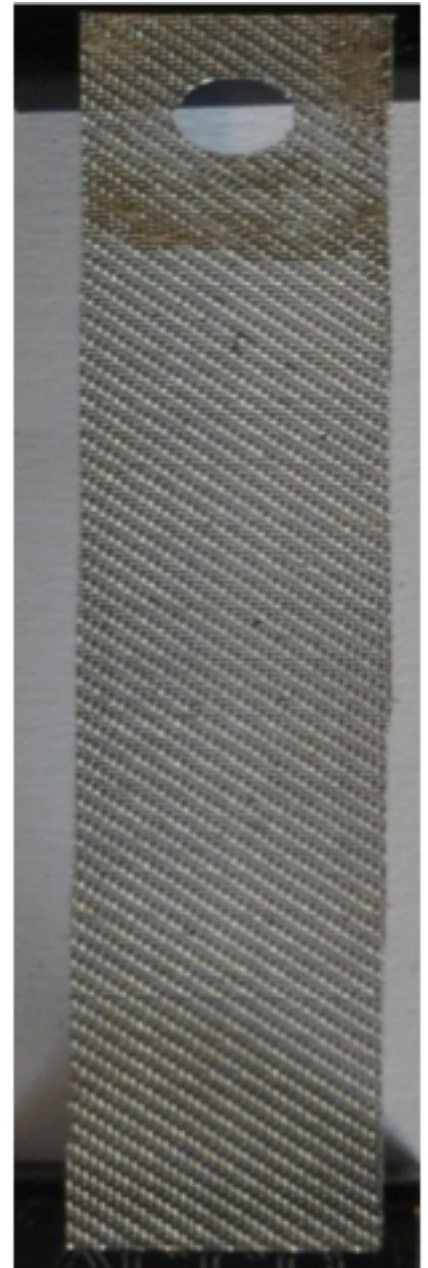
## ORGANIC CONTAMINATION ACCUMULATION

Cooling Tower with Sphagnum Moss in addition  
to two biocides, a dispersant  
and corrosion inhibitor.

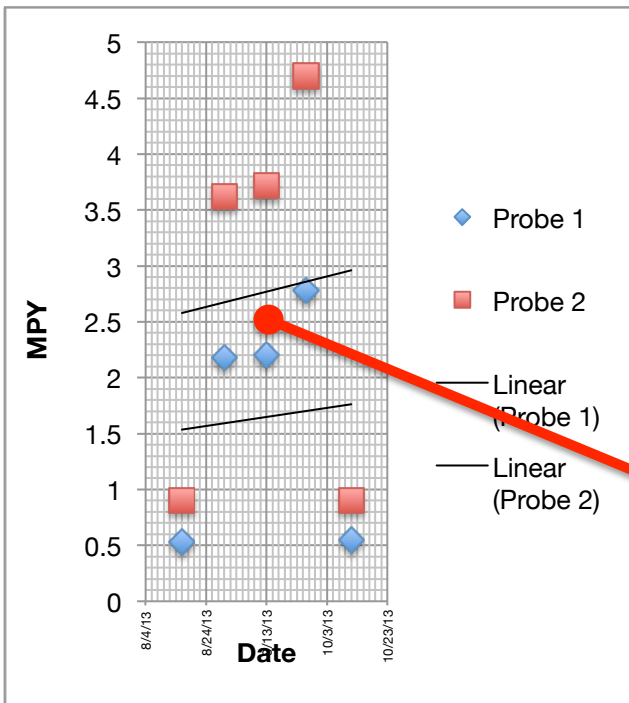
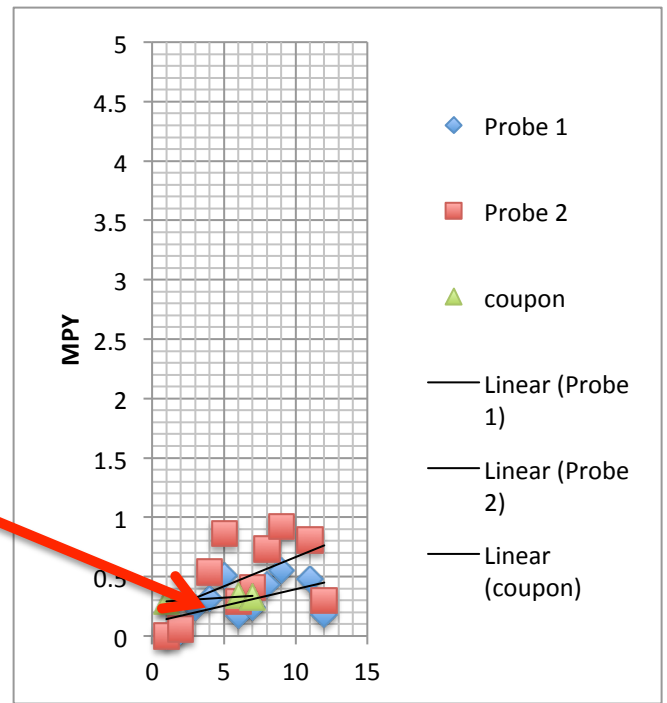
Treatment of the towers with Sphagnum moss resulted in 90% reduction in corrosion for copper and 100% reductions in organic contamination when compared to the control tower. Figure 5A and 5B.

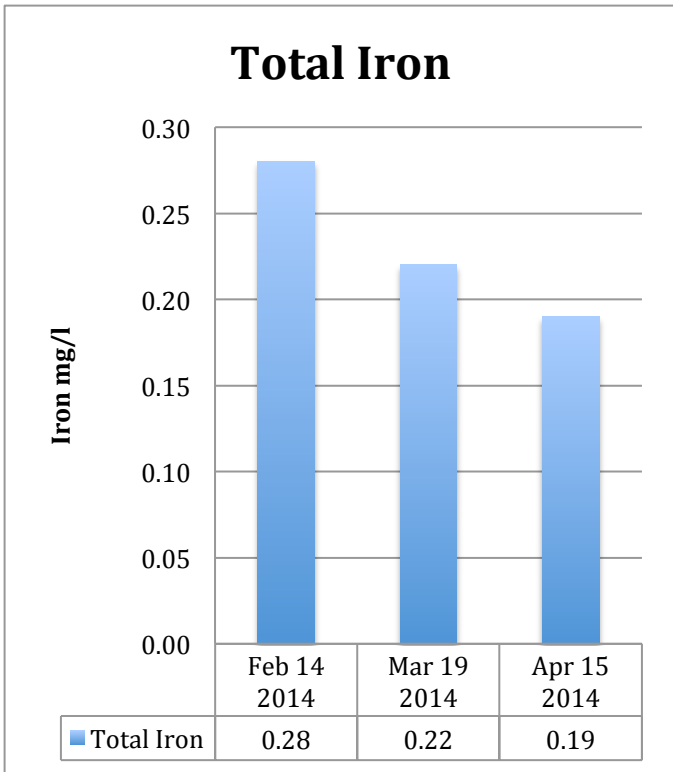
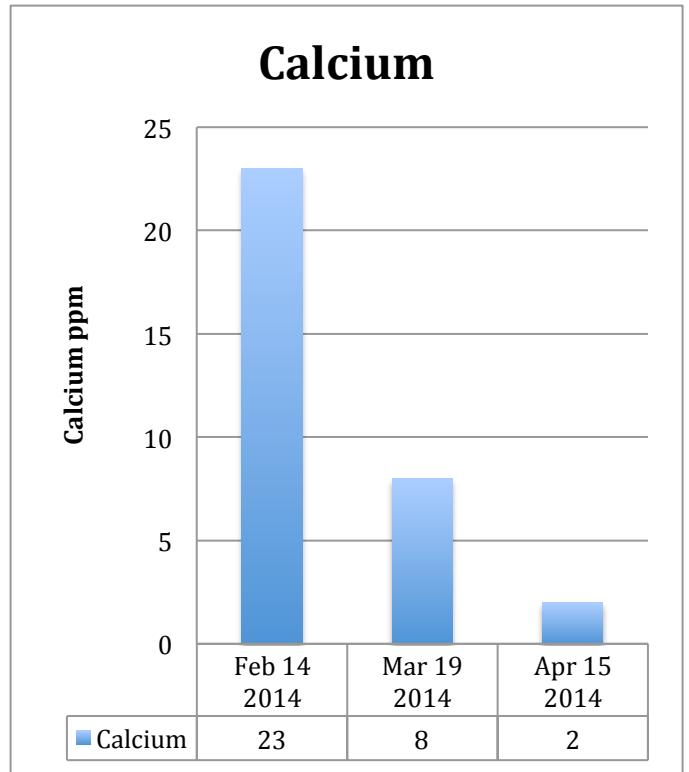
Pre treatment with ProMoss™

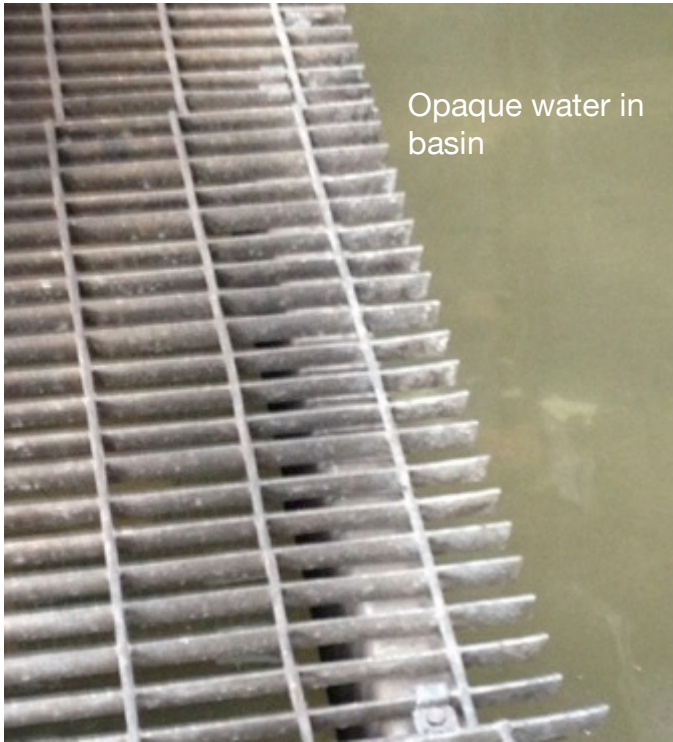
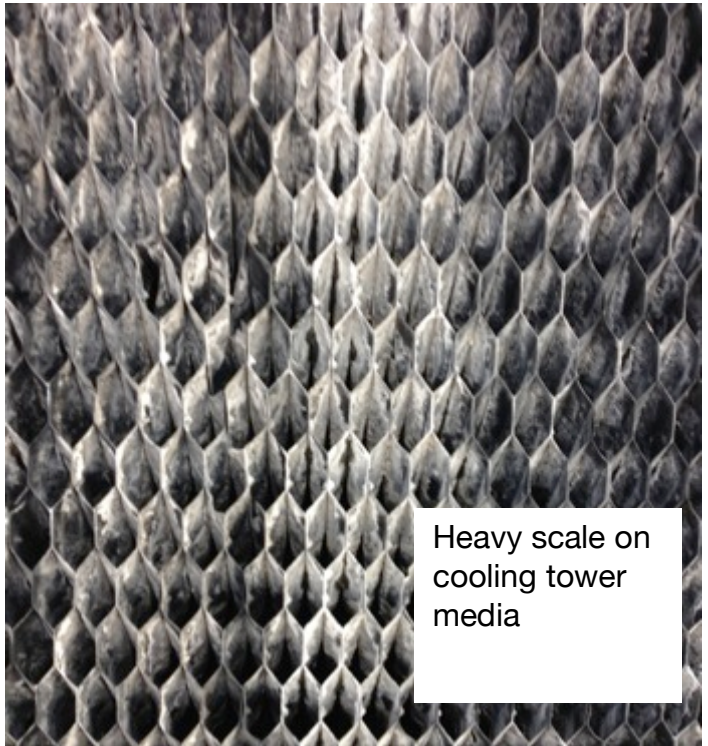
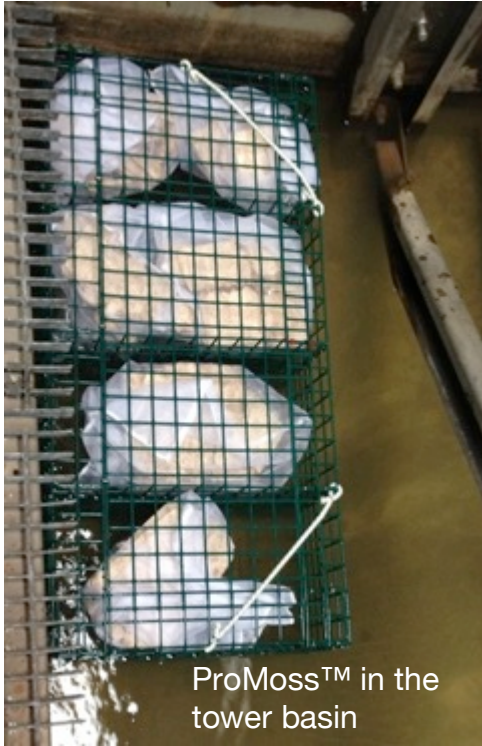
ProMoss™ in the tower basin

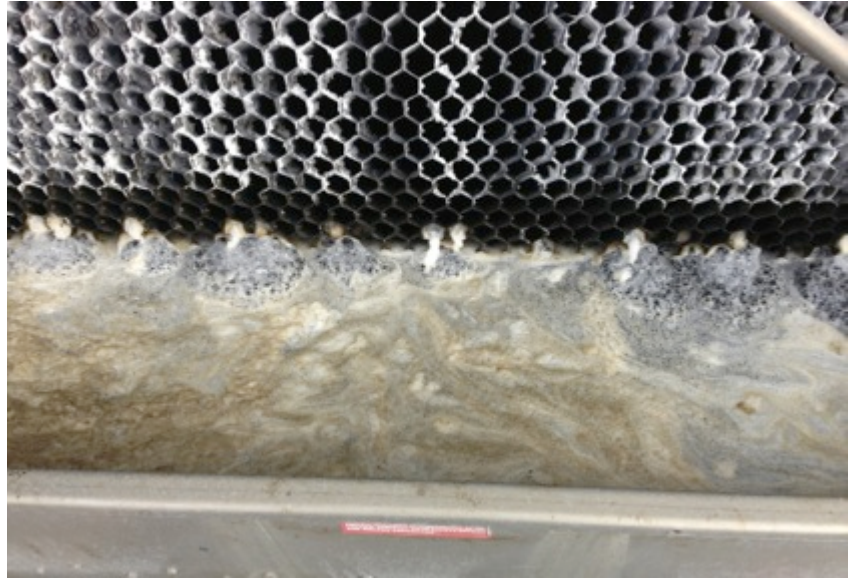
*Foaming in return water (note foam coming from the media)*

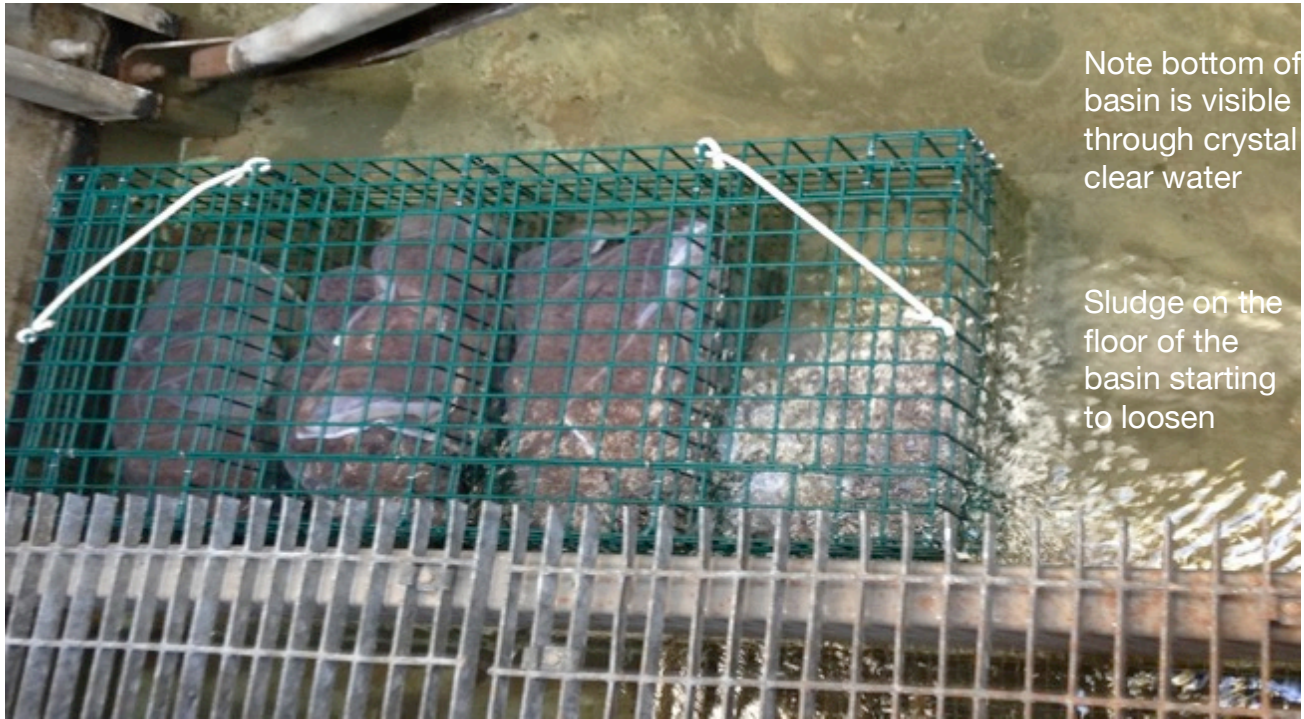
Two Months treatment with ProMoss™

Note bottom of basin is visible through crystal clear water

Treatment with ProMoss™ for two months resulted in significant improvements in water clarity, decrease in foaming, scale removal from the areas in contact with the water, and reductions in iron and calcium ion concentration with no change in the water treatment regimen.

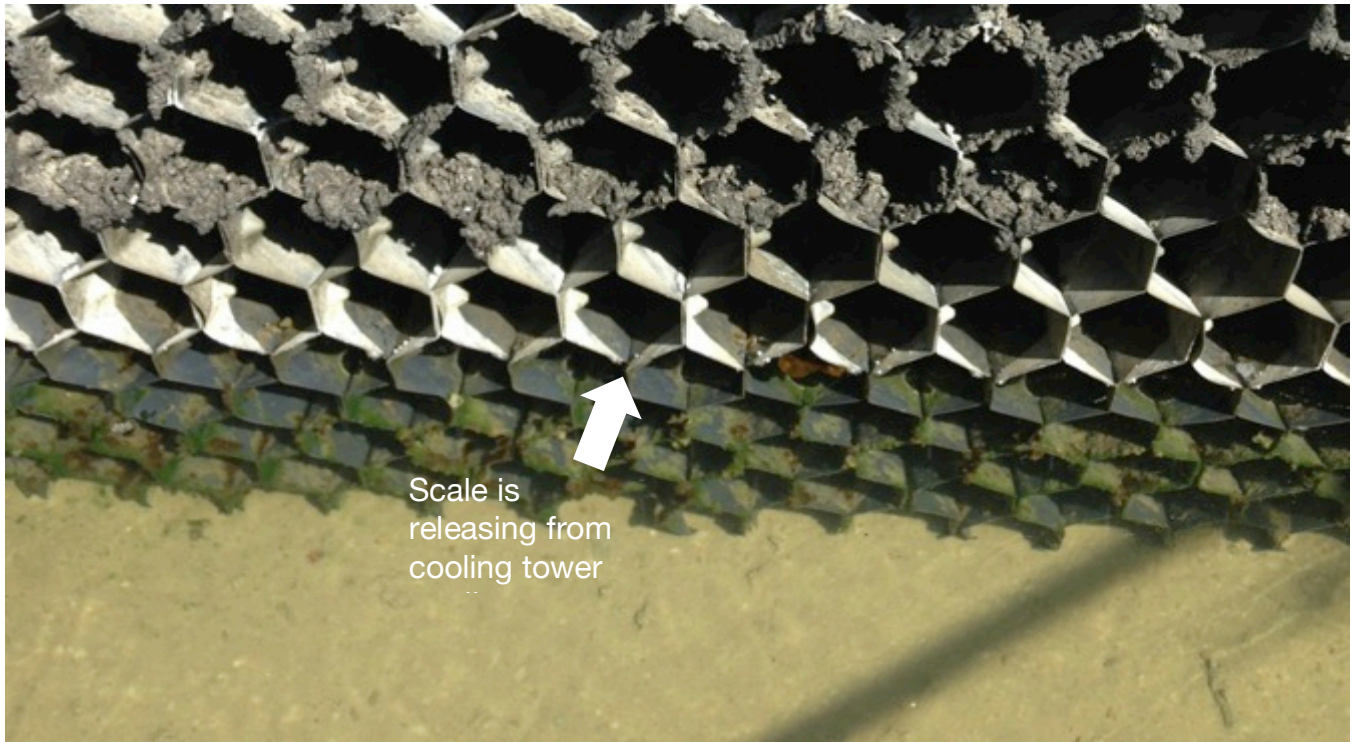
Sludge on the floor of the basin starting to loosen
